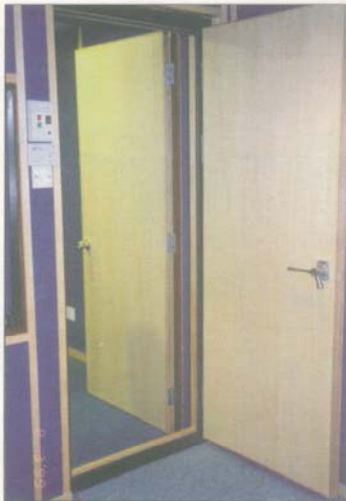
1. Acoustic doors

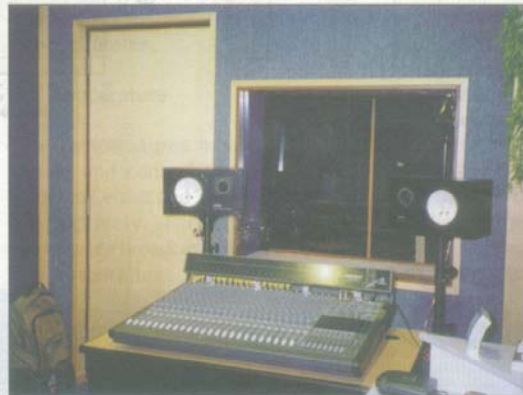
2. Observation window of the studio

An 1200mm x 1150mm (L x W) observation window was installed in between the control room and the studio, at a height of about 750 mm from the floor, (see Photo No. 2). Two different thicknesses of glasses were used in order to avoid resonance, if any. One layer of them is detachable and can be opened for cleaning, if necessary. Silica crystals were placed inside to absorb moisture.

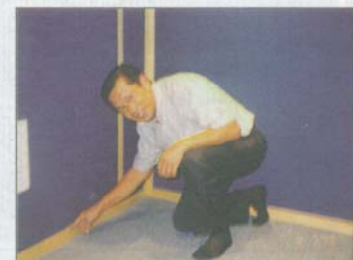
3. Acoustic contractor checking the wall treatment

(c) All wall surfaces were fixed with 50mm 80 kg/m<sup>3</sup> rock wool and covered with acoustic transparent fabric and framed with ramin wooden strips. Photo No. 3, showing the acoustic contractor checking the wall treatment after completion.
